Re: Claim #: 040515008195
Insured: Versatube Corporation
4755 Rochester Rd., Troy, Michigan 48085
Our File: Versatube Corp

Subject: Versatube Corp. Sheppard Report, Beam Repairs, and Codes

VERSATUBE STAMPING PLANT
INSPECTION OF FIRE DAMAGE REPAIRS
4755 ROCHESTER ROAD, TROY MI

Versatube Stamping Plant
Fire Damage Repair Inspection
by Stephen M. Rudner, P.E. on June 2, 2017

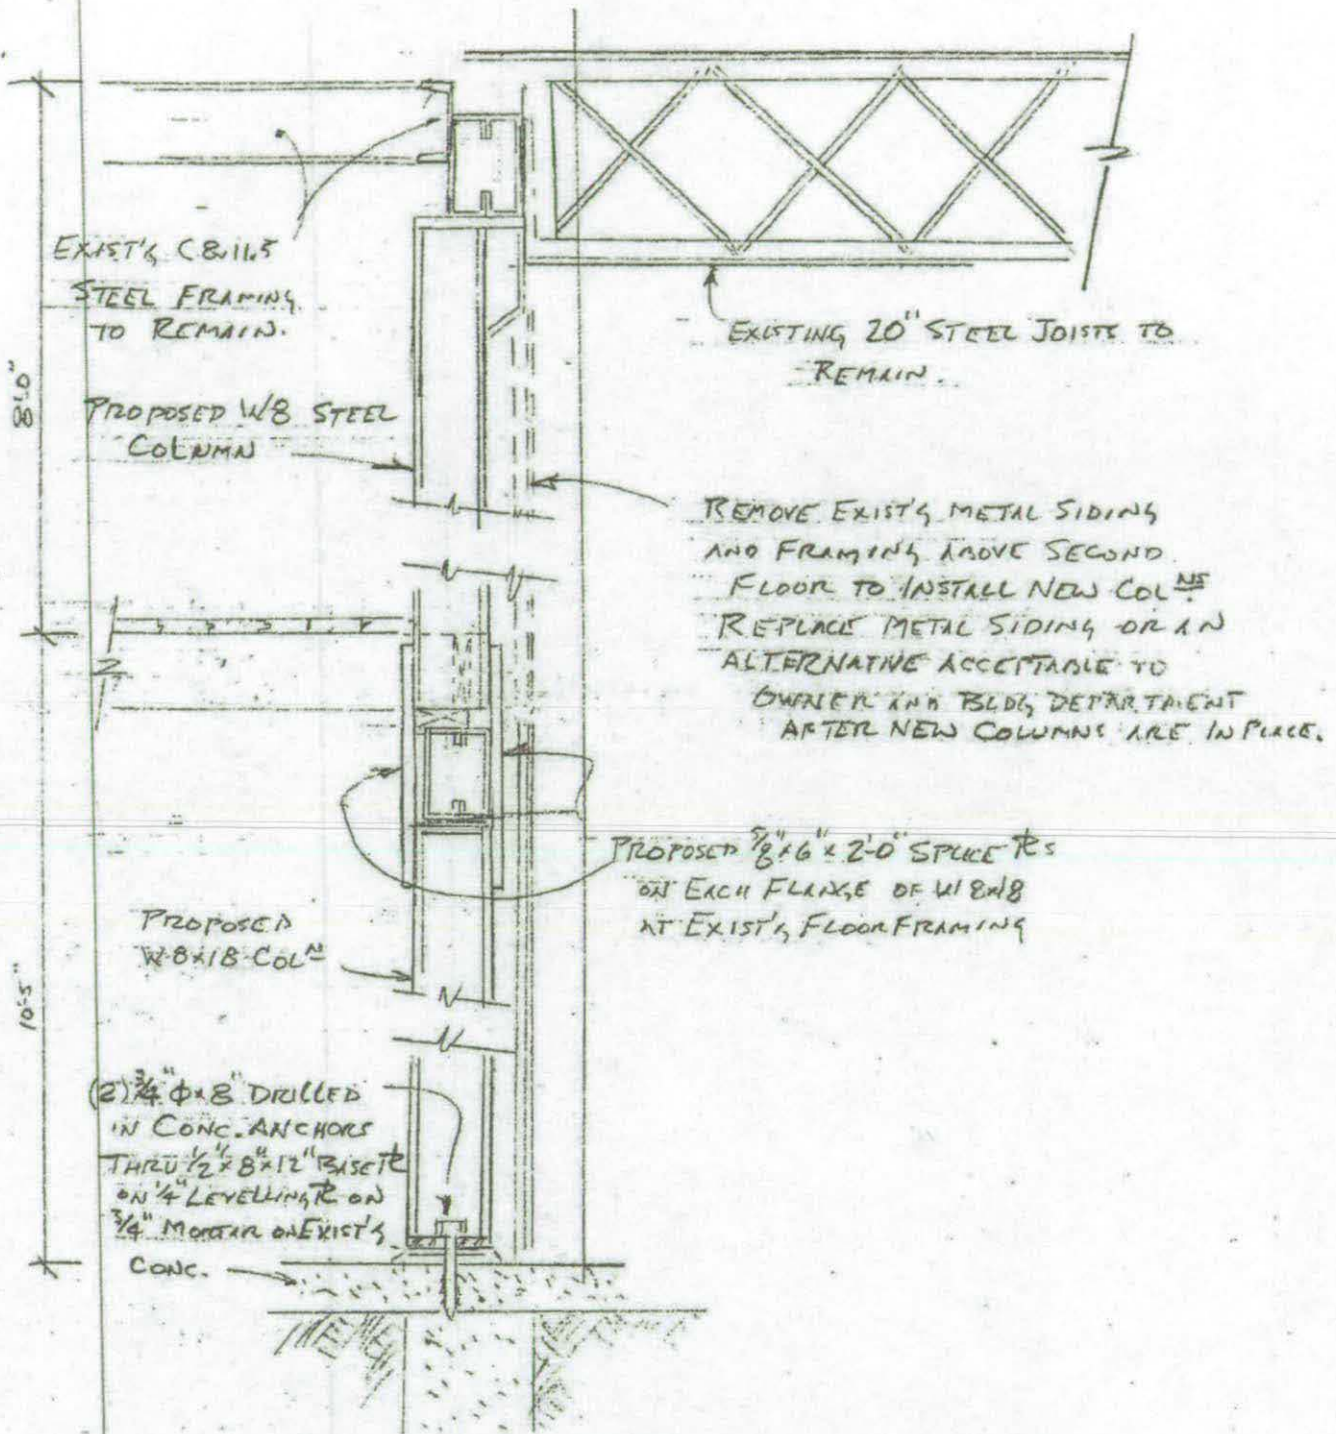
SK-2(JPC)

7. (4/15/15) The sketches issued indicate an alternate approach to beam replacement without stipulating details of the structural welding connections including but not limited to:

- D. Refer to Robert Darvas Assocs. (RDA) report authored by Steve Rudner, PE. (Appendix C).
- E. The structural integrity of the column welds, the lack of specificity on the Sheppard sketches with respect to the welder certification, welding process, etc., whether or not a trench footing exists, and the soil pressure beneath the footing, if it exists are, in my opinion, sufficient unknowns to render the installation unsafe.

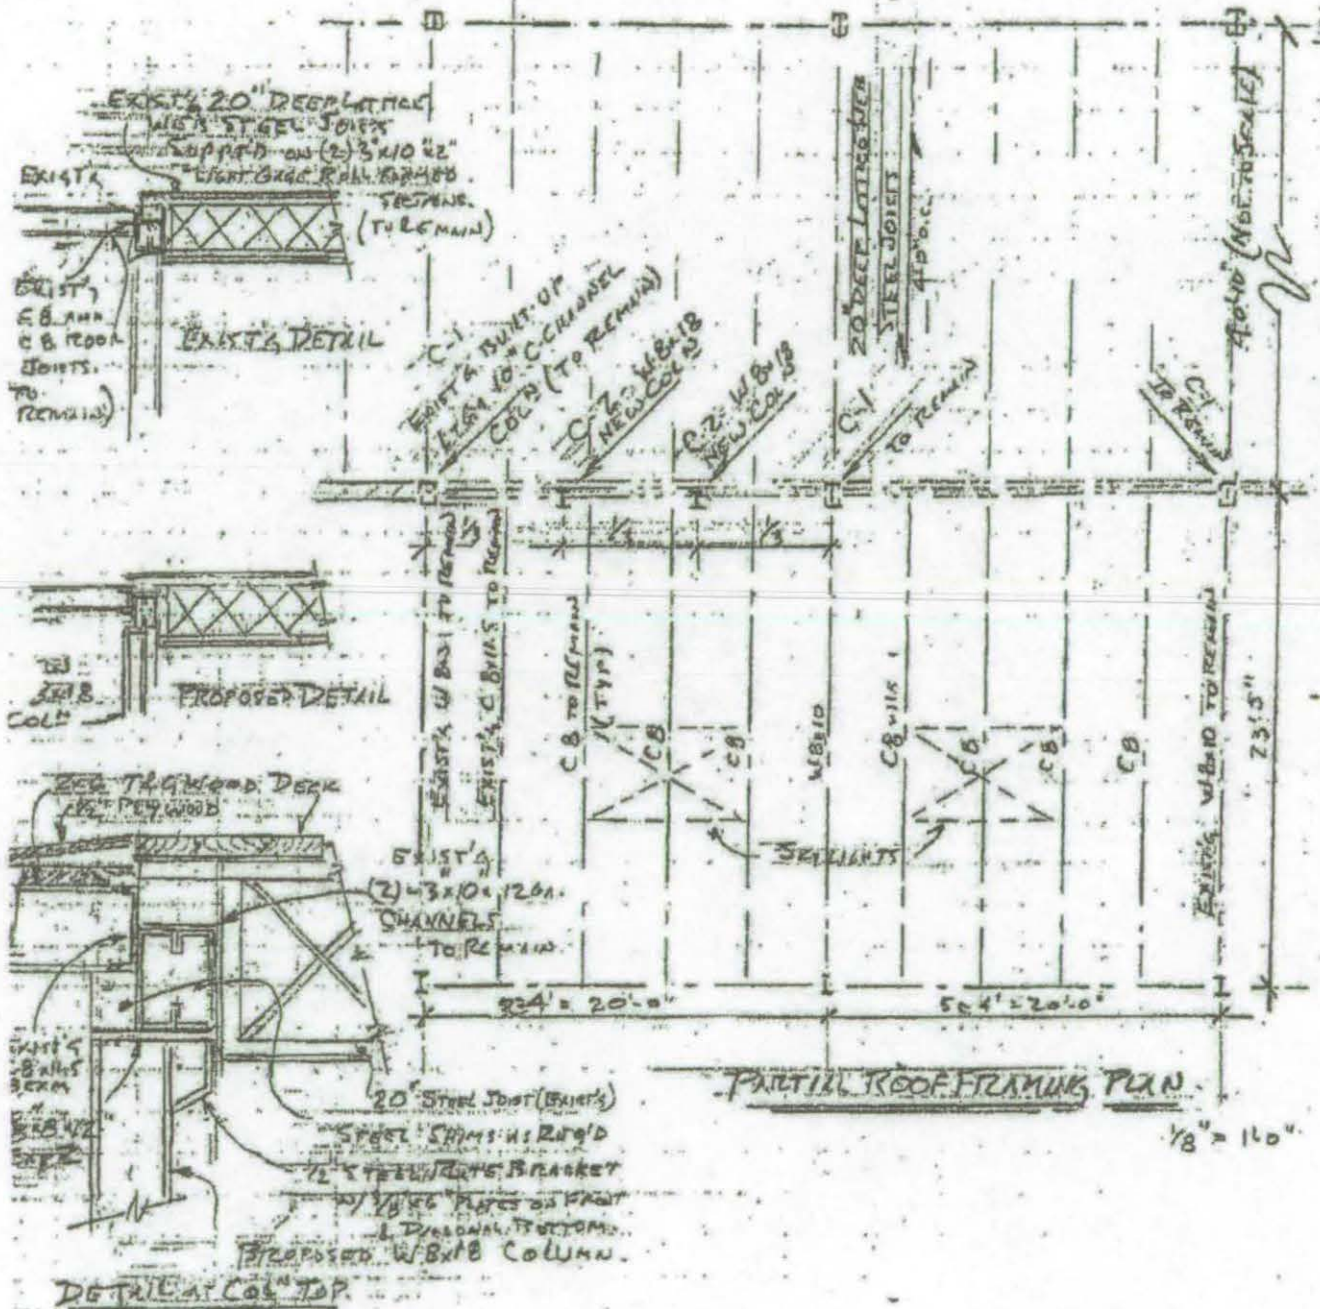
SK-3 (JAC)

5. (2/13/15) Four sketches, SK-3 (JPC) through SK-7 (JPC) are undated.
6. (2/13/15) Page 2, paragraph 1, 2nd and 3rd sentence states: "*The 2-foot length of this beam has a buckle in the bottom flange and deflection of the beam-itself-That-beam-should-be-removed-and-replaced-with-a-larger-beam.*"
I concur.

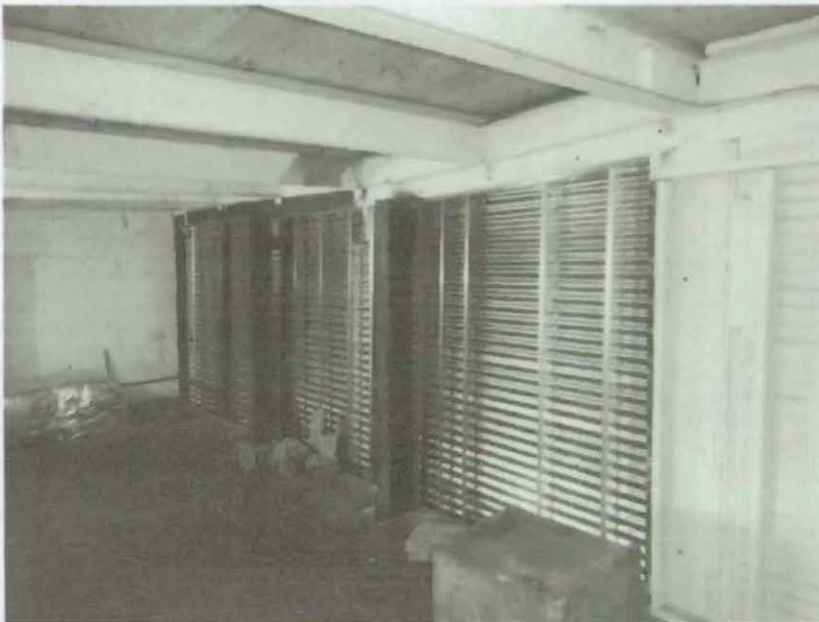
Photo #20 - Overall view of upper wall looking ESE.
